### Freak or Frequent?

# BOSCASTLE The Flood

16:08:2004

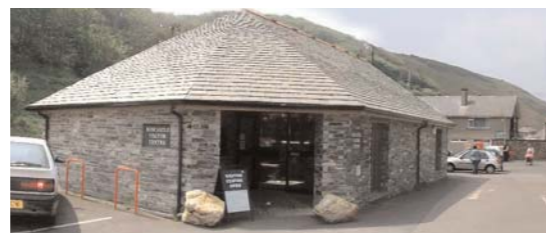
(right) The Boscastle Visitor Centre, a popular attraction, where some 100,000 visitors had already called in 2004.

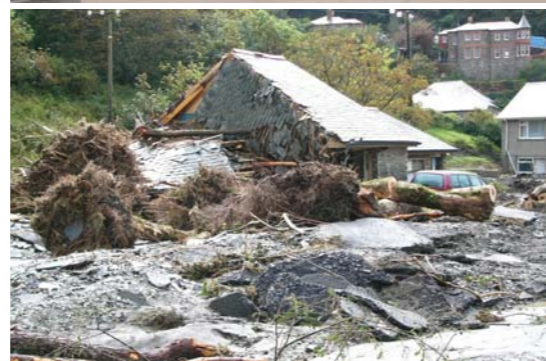
(right) The aftermath. It was from the small remaining roof space of the building that 12 people were eventually airlifted to safety whilst the structure was literally dissolving into the deluge below them.

- 16.20 A footbridge is washed away.
- 16.22 Rescue helicopters 169 from RAF Chivenor and 193 from RNAS Culdrose are scrambled.
- 16.30 All access roads to Boscastle are closed by the Police. A further wall of floodwater rides through Boscastle car park and crashes into the Visitor Centre. Water now entering the Visitor Centre, the double doors are breaking.

- 16.52 Severe flooding is reported by the Police helicopter.
- 17:00 The Boscastle floods are approaching peak level. Cars are being washed out of the car park. There is an almighty crash and the whole of the Visitor Centre building is shaken. The end wall collapses along with the roof. The waters, some 2½ m (8ft) deep, are now lapping the top step of the attic ladder. 9 climb out of the velux window onto the remaining roof of the Centre, whilst 3 wait inside. The rain is so heavy that it is hard to see a few feet away.
