## Work aims to reduce flood risk

**As well as improving Boscastle's flood defences, the Environment Agency is working with the National Trust and other landowners to reduce the risk of trees being washed down the River Valency in a flood. We have produced this factsheet to tell the public about the work.**

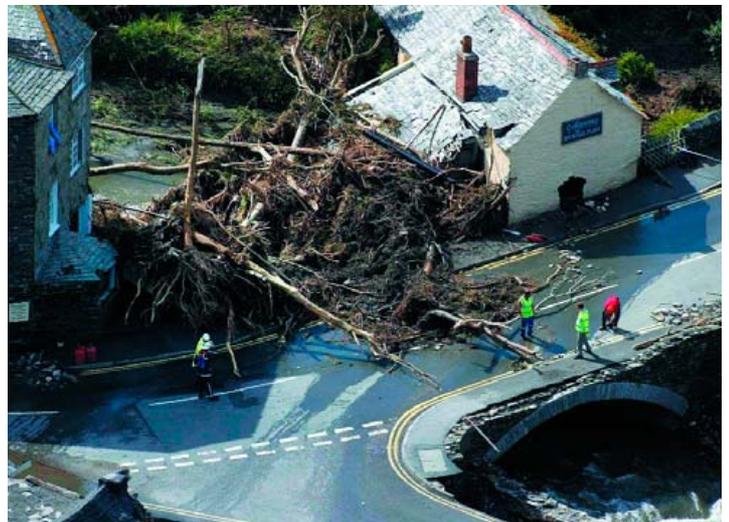
*Above: The problem – trees washed down the River Valency on 16 August 2004 worsened the flooding*

More than 40 homes and business were flooded and many people had to be rescued by helicopter. Fortunately no lives were lost. The floodwaters washed away trees in the Valency Valley and carried them downstream. The trees, other debris and cars were swept down from the car park, blocking both bridges.

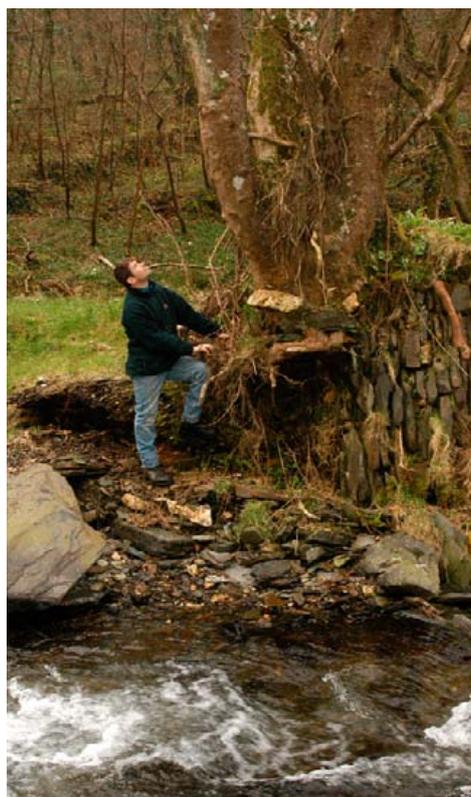
*Left: Coppicing riverside trees such as this in the Valency Valley will reduce the risk of them being washed downstream*

Full-height trees growing from the riverbank between Newmills and Boscastle are at risk of being washed into the village during floods. This is what happened in August 2004. Coppicing these trees reduces their height and weight while retaining a wide root base, which means their stability is greatly increased.

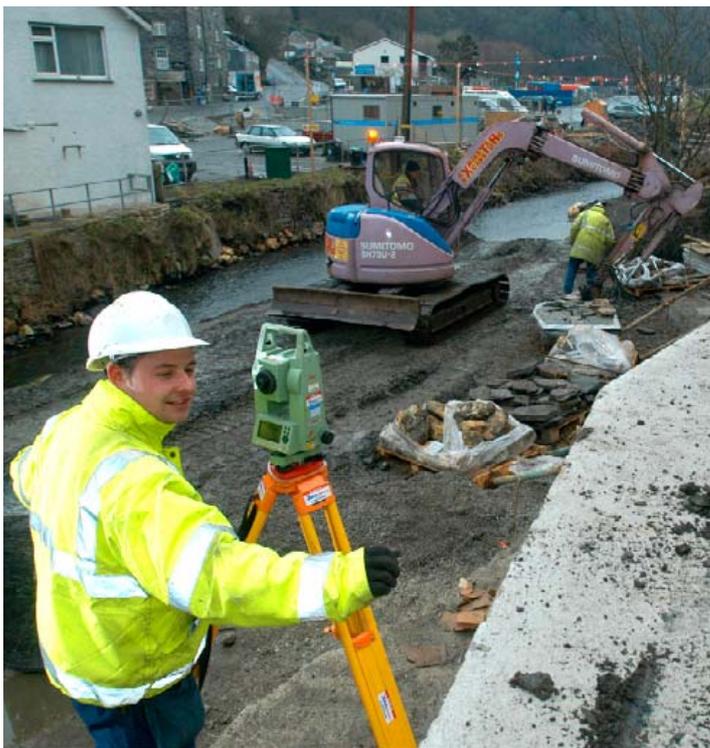
Work on improving flood defences in Boscastle

The work involves lowering and widening the river channel so it can carry more water, and raising the height of the car park so vehicles are less at risk of being washed away by another flood. The car park is being moved further from the Valency to make more space for the river and create an area for sediment to be deposited.

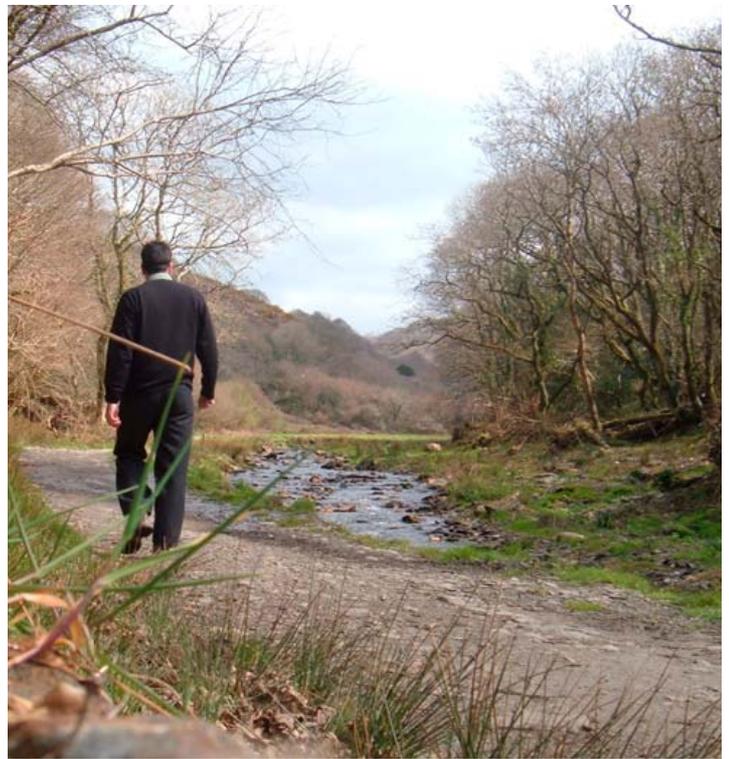
*Walking by the river in the Valency Valley between Newmills and Boscastle: Trees on the river bank will be coppiced, while unstable trees on the floodplain may be felled or coppiced*

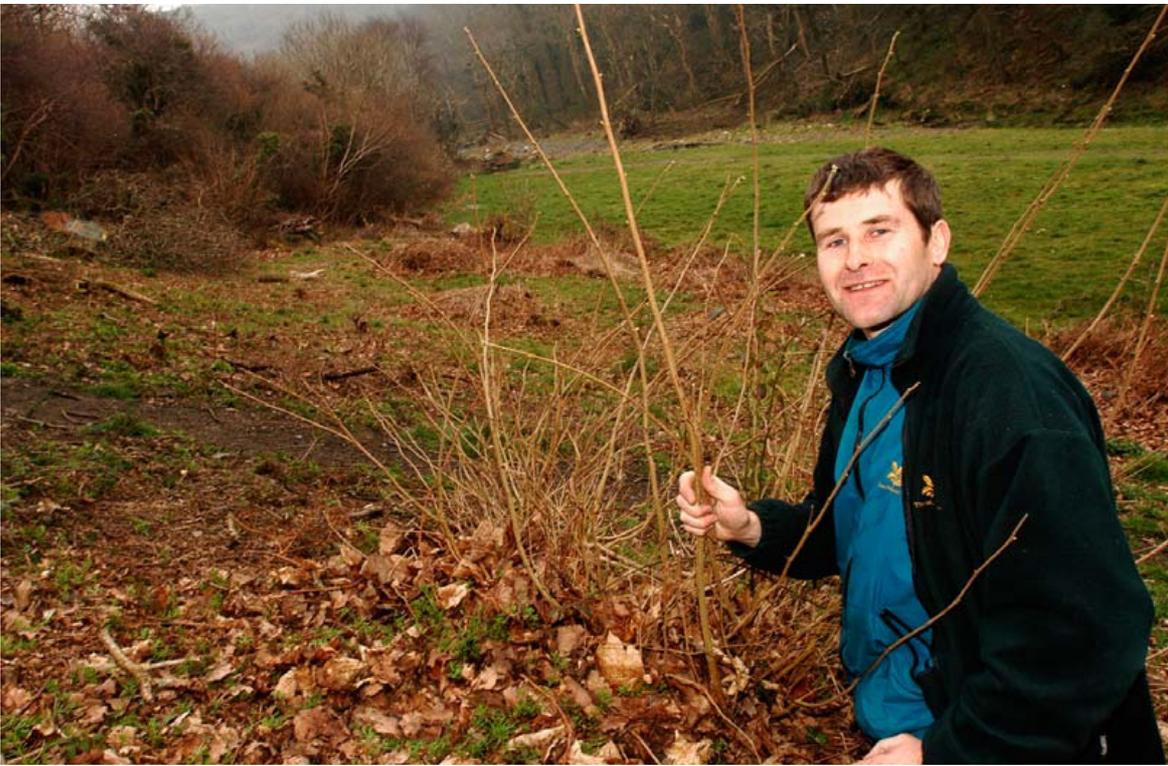
*Jeff Cherrington of the National Trust with coppice regrowth in the Valency Valley*

- Woody debris over two metres long will be cleared from the river.
- Cutting woody debris in the immediate floodplain to less than two metres or moving it outside the floodplain.
- Coppicing\* all trees growing on the riverbanks.
- Regular inspections of all trees in the immediate floodplain for signs of instability. These may be felled or coppiced.
- Maintaining tree cover in the immediate floodplain at current levels by limiting the height of sapling regrowth through coppicing or felling. Selected saplings will be allowed to grow into mature trees to replace those which are felled.

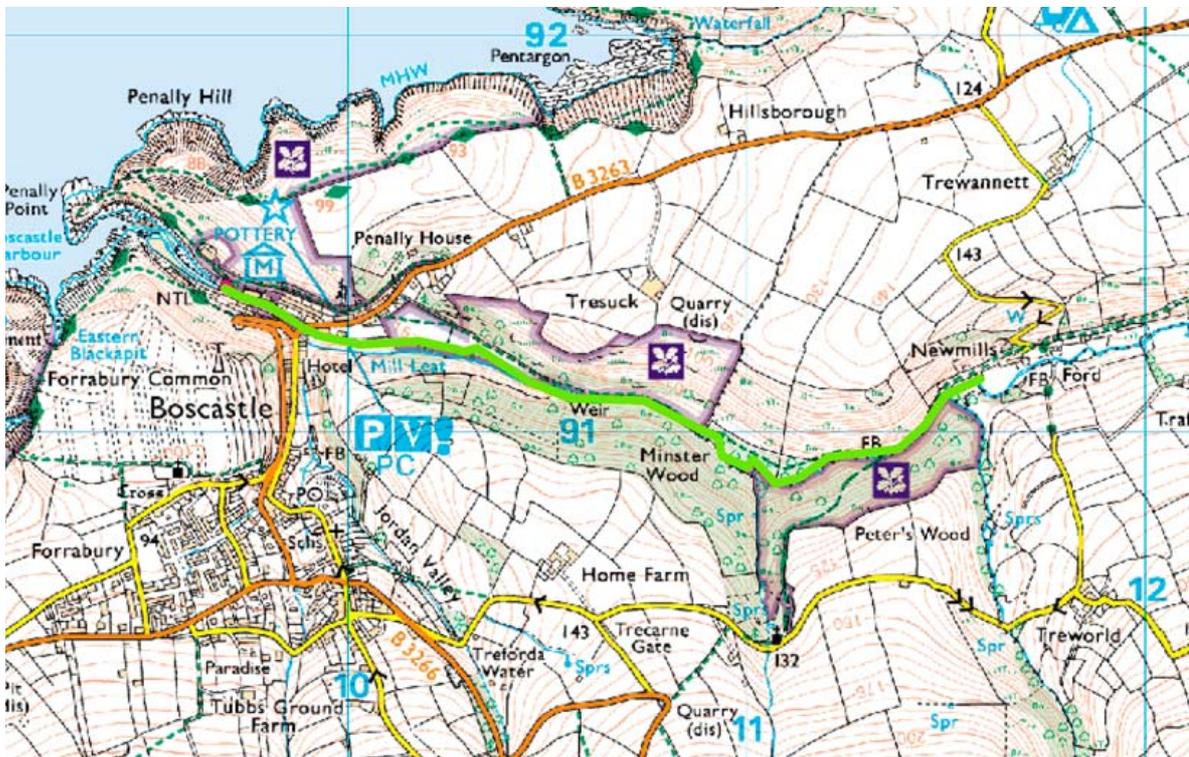
*Map of the Boscastle area: Highlighted in green is the section of the Valency Valley to be actively managed*
